**High Street Green, Hemel Hempstead
Hertfordshire, HP2 7AQ**

**NDT/Geophysical Investigation
of Collapsed Ground**

Final Report - 4281

Hertfordshire County Council

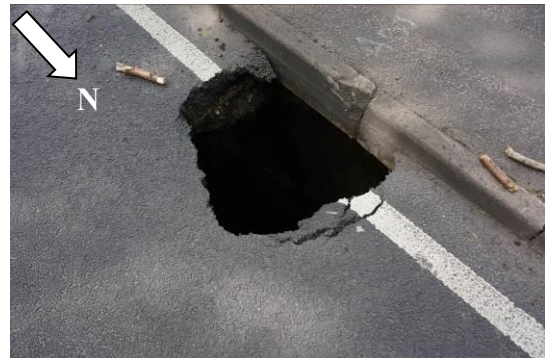
A 'hole' opened up suddenly in the road at the western side of the High Street Green carriageway, near the intersection with Branksome Close on Friday 12th May 2017. The 'hole' measures approximately c.500mm x c.500mm in plan and the void beneath was understood to be up to c.8m in depth.

Plate 1 – Close up image of the 'hole'.

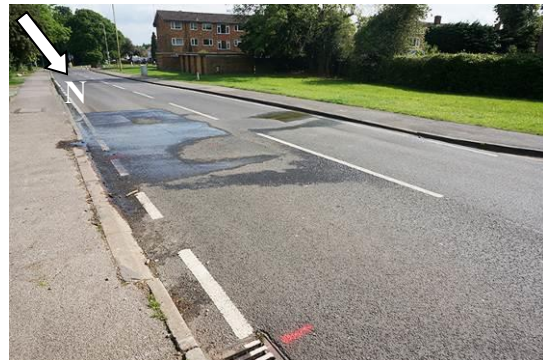
In addition to the ‘hole’, further along the road to the south, there is an area where water is visible on the High Street Green Road surface, located immediately to the south of the entrance road into Eastwood Court. It was observed that water was slowly leaking onto the carriageway from below appeared to flow continuously. The water was discoloured with a slight foul smell with frequent suspended sand grains.

Plate 2 – Area of visible surface water.

It is probable that the water at the surface is related to a leaking service within the ground. Due to the 'instability' in the area, including the void formation to the north of this zone it is possible that as a result of leaking service(s) this could develop into a subsurface void, if it has not already. Therefore, it is recommended that

careful intrusive investigations are undertaken in this area to expose any possible services. Care should be taken to not damage any of the services.

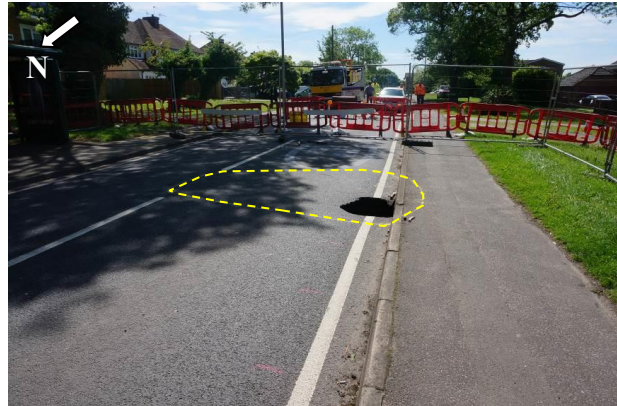
At the request of the Client, the approximate extent of the void below and around the 'hole' was marked on the ground surface. This outline was approximated based on the apparent horizontal laser measurements and has since been superseded by the extent shown on the accompanying GBG

Plate 6 – Approximate extent of void marked on surface by GBG.

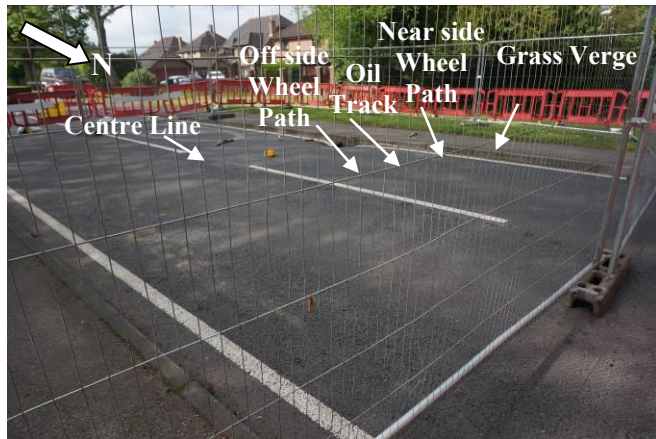
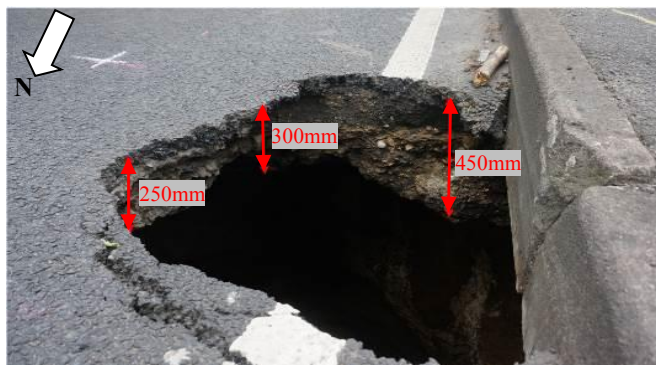
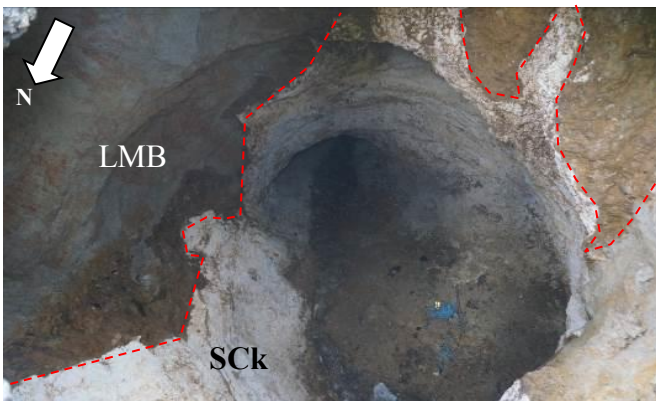
The ground surface is variable; consisting of either asphalt in the carriageway and footpath and grass verge to either side of the footpaths. The thickness of the asphalt was variable ranging from c.250-c.500mm (as shown opposite) but was typically c.400-450mm in thickness above subbase/subgrade materials

The natural ground as observed in the void viewed through ‘hole’ location is silty and sandy clay most likely belonging to the Lambeth Group (LMB) above chalk bedrock of the Lewes Nodular Chalk and Seaford Chalk Formation (SCh). The boundary between the LMB and SCh is highly variable.

Plate 7 – (Top) General image. (Middle) Construction of carriageway at ‘hole’. (Below) Geological succession, red line indicates geological boundary.

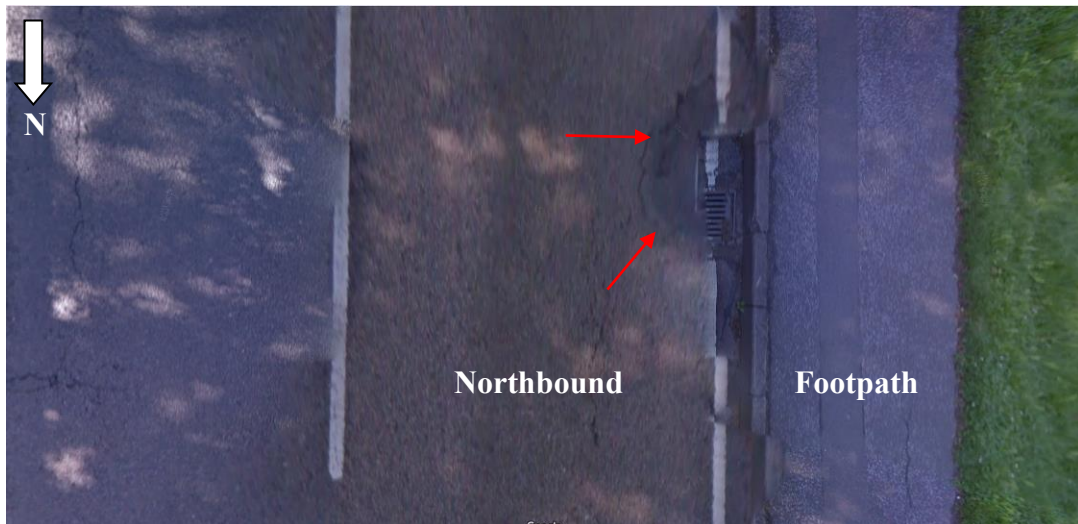
Aerial photographs from recent years found by internet searches show that that subsidence at the site has been ongoing for several years. The image below indicates that subsidence has occurred from at least July 2012. In this image tension cracks are visible consistent with subsidence around the gully where the present day hole is located.

Figure 2 – Image of ‘hole’ location as shown with the red arrows in July 2012. Not to Scale.

The image is the earliest available that could be found via the internet and it is possible that subsidence could have been occurring earlier than this.

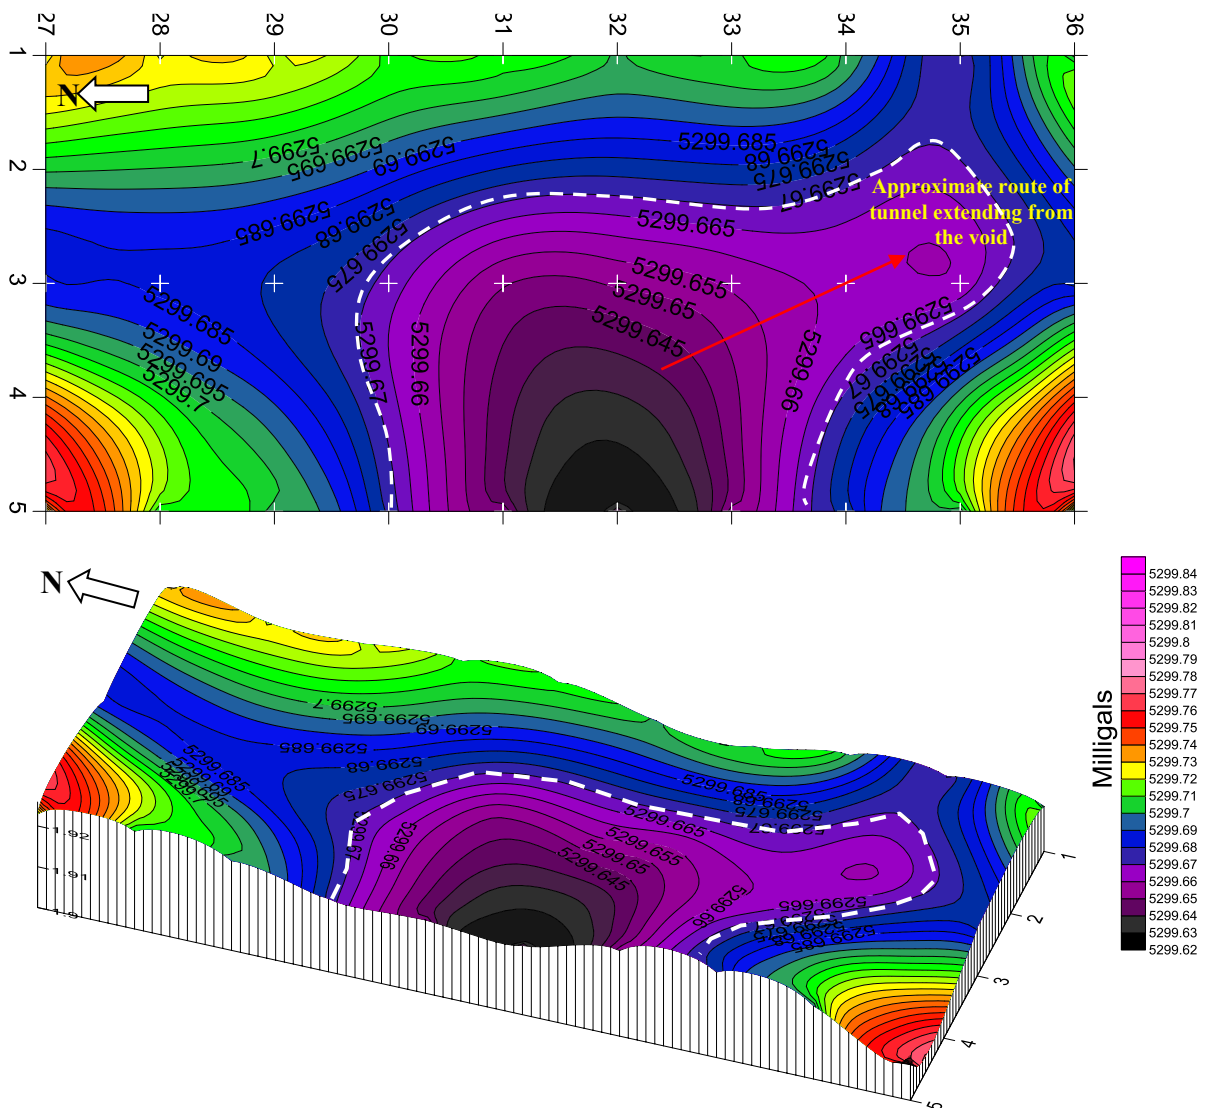
The findings of the microgravity generally match the findings of the impulse radar. An area of low gravity shown by the black and dark purple shading has been interpreted as the void and matches well with the dashed outline of the void identified from the radar. An area of lower gravity also appears to extend away from this voids towards the south east, which is consistent with a subsurface ‘tunnel’ (discussed in further detail below – Section 3.5). The approximate extent of the ‘void’ and ‘tunnel’ has been indicated by the white line on the image below.

Figure 4 – (Top) General image showing only the road gravity data (Below) 3D image showing the same data. Area of increased engineering risk shown with area delineated with white dash.

The dark blue areas are of relatively low gravity but higher than that of the black and purple in and around the known subsurface void and ‘tunnel’ beneath. These areas are denser and are likely to represent disturbed areas of ground which is currently stable.

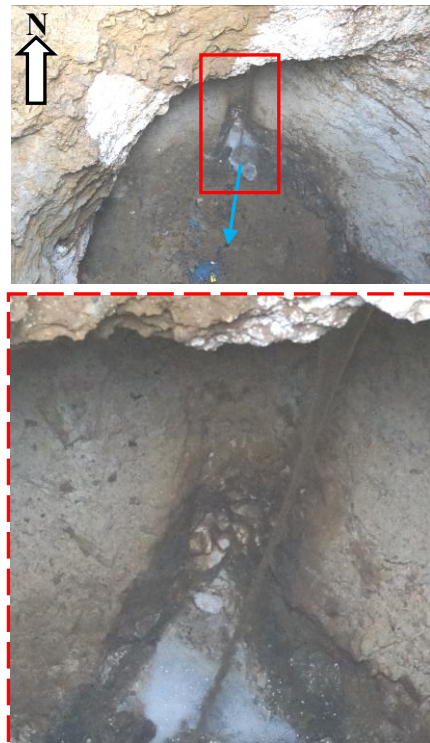
Plate 8 – Leaking Service. Flow direction shown in blue.

When looking into the void via the ‘hole’ running water could be seen and heard and the smell from this was consistent with foul water. A service at an approximate

depth of c.5m (although no depth measurements could be taken due to the shape of the ‘hole’) could be seen to the north side of the void. The outflow was strong flowing to the south east from the severed/broken end of the pipe into the void. The pipe could not be seen directly therefore the diameter, approximate depth and construction could not be determined.

The base of the void was sufficiently incised to indicate that the water had flowed for a considerable amount of time. The water could be seen flowing from the void into the adjoining tunnel (discussed below).

It is not known whether the leaking service has occurred as a result of pre-existing ground instability within the chalk or if the leaking service over a period of time is directly attributable to the formation of the void i.e. the dissolution of the bedrock.

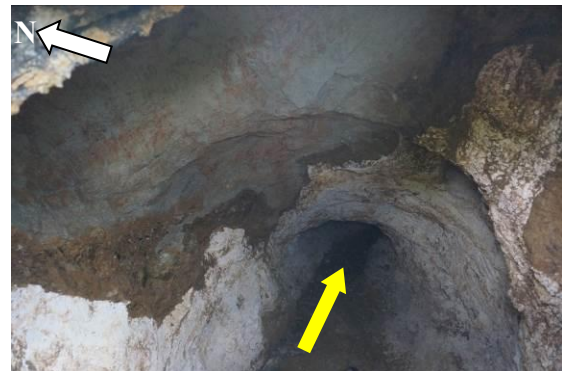
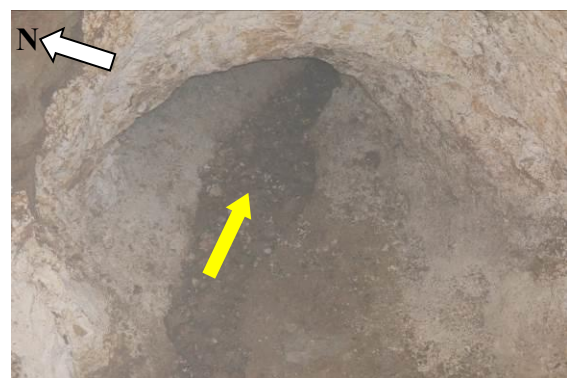
At the base of the void an adjoining subsurface feature (‘tunnel’) can be seen to extend south eastwards away from the void– shown opposite. The tunnel is cylindrical in shape (c.1-2m in diameter) and located approximately at a depth of c.6-6.5m (Note that due to the geometry of the void accurate depth measurements/dimensions were difficult to achieve).

This feature is consistent with a subsurface ‘tunnel’ through the chalk bedrock but it is not known whether

Plate 9 – (Top) General image showing the tunnel location at the base of the void. (Below) Close up of assumed tunnel.

this is natural, pre-dating the leaking from the service, or is directly attributed to the leakage from the service.

Within the void there is nothing visually to indicate that the leaking service would remain straight, therefore if the 'tunnel' is a continuation of the leaking service there would be a kink in its route, from north-south near the west footpath, to a more south easterly direction which possibly crosses the carriageway. From what can be seen from the 'hole' above there does not appear to be any of the service left within the 'tunnel' Additionally, the depth of the leaking service is shallower than the 'tunnel' indicating a significant change in level, which would be unlikely when constructing a pipe. However, the depths are approximated and it is possible that inaccuracies should mean a less significant change in height consistent with continuation of the service into the 'tunnel'.

- A suspected subsurface tunnel was observed extending to a distance of at least c.5.5m to the southeast of the void.
- It is recommended that the 'tunnel' is investigated further to confirm its eastern extent and to confirm that it is not part of a more expansive 'tunnel' network.

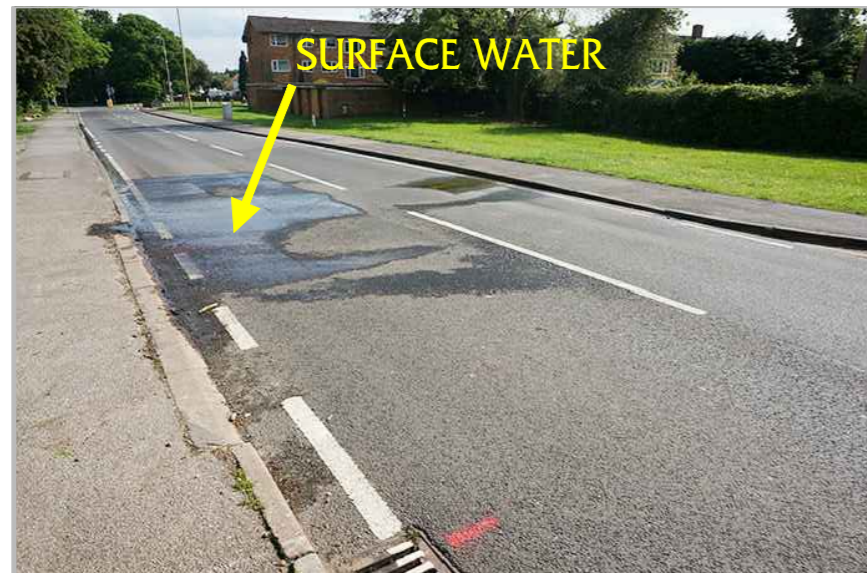
An area of visible surface water was observed to the south of the Eastwood Court Access Road between chainage c.130-140m. The water was mostly limited to the southbound lane. Anecdotal evidence indicates that the presence of surface water has been ongoing for several months, irrespective of rainfall and temperature variation.

P1c: AREA OF VISIBLE SURFACE WATER BETWEEN CHAINAGE c.135-145m LOOKING SOUTH

- Surface water to the south of the Eastwood Court Access Road is likely to be as a result of a leaking service(s) within the ground. It is recommended that this area is investigated immediately either through intrusive or geophysical techniques or a combination of both.

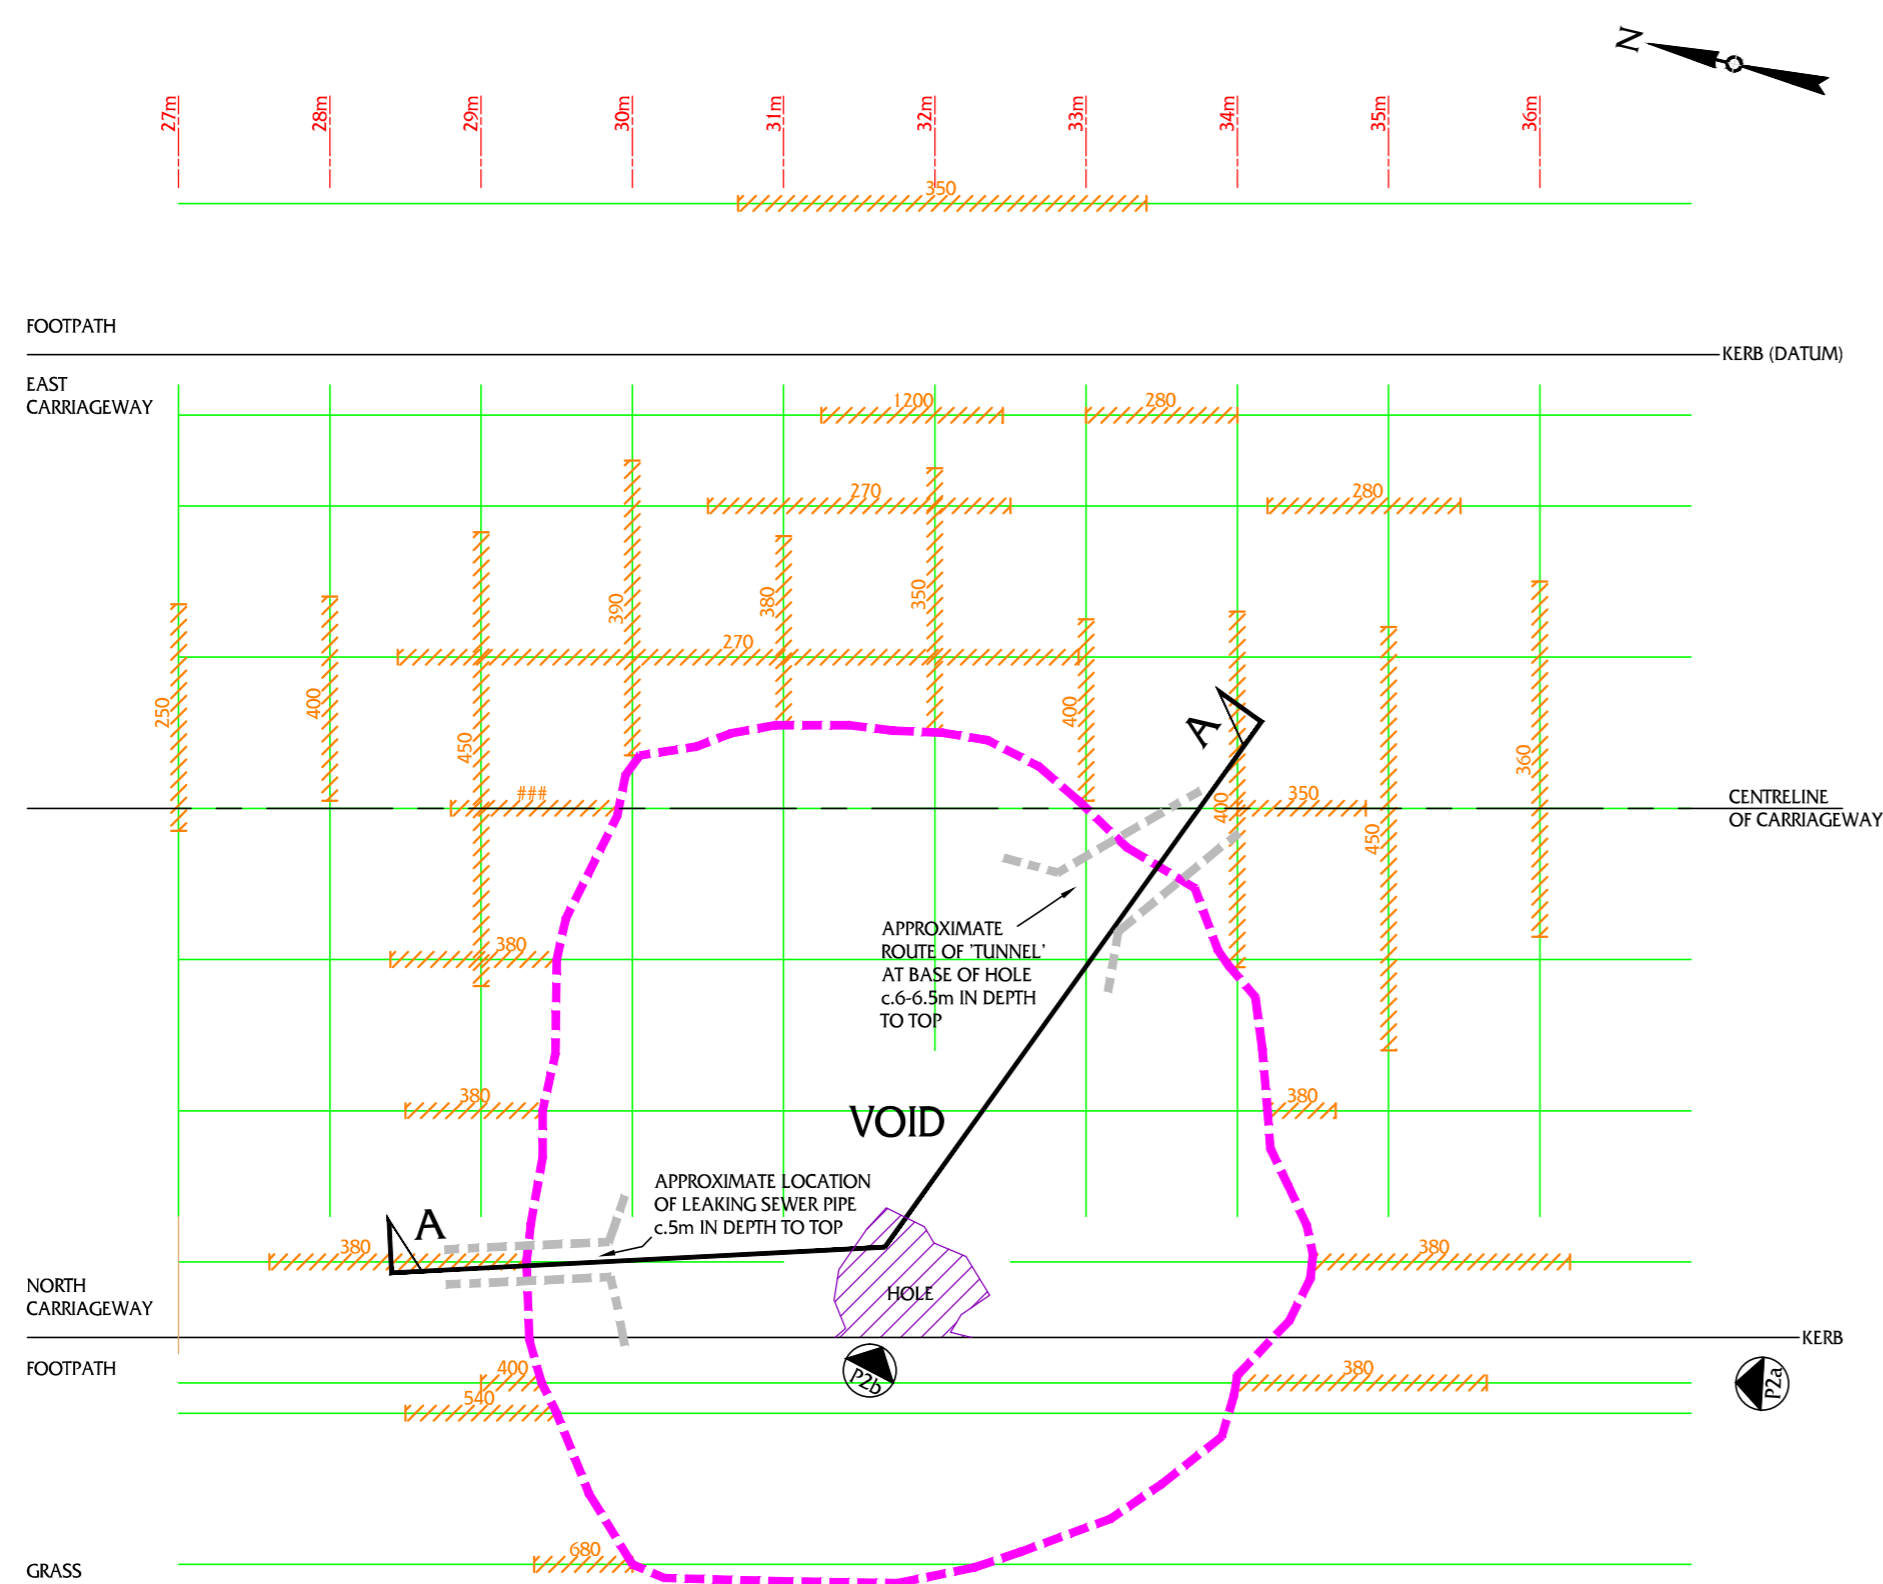
FIG.2: PLAN OF DETAILED SURVEY AREA SHOWING 'VOID' EXTENT - IMPULSE RADAR RESULTS SCALE 1:50

The plan extent of the void below the ‘hole’ is denoted by a magenta dashed outline at Figs.1 to 4 on drawings 4281 & 2.

The magenta outline showing the extent of the void has been determined from analysis of the collected impulse radar data supplemented with physical measurements taken onsite. This line approximately delineates a change from generally well compacted ground to voided ground outside of this line where the ground is well compacted the asphalt is likely to be in immediate contact with the subbase and natural ground alike, however some of this ground may be disturbed (described in detail below). Within the area of this line, the road surfacing materials (asphalt & Subbase) are either poorly supported or entirely unsupported

The void is c. 5.1m in long by c.5.8m wide (east-west) by c.7.6m in depth equating to at least c.69.46m³ ($V=4/3\pi r^3$) Note that this does not include the volume of the ‘tunnel’ void (discussed below). The void extends from beyond the west footpath to beyond the centre line of the road (to the east). Its north-south extent is from chainage c. 29.1m to 34.2m measured from the main survey datum.

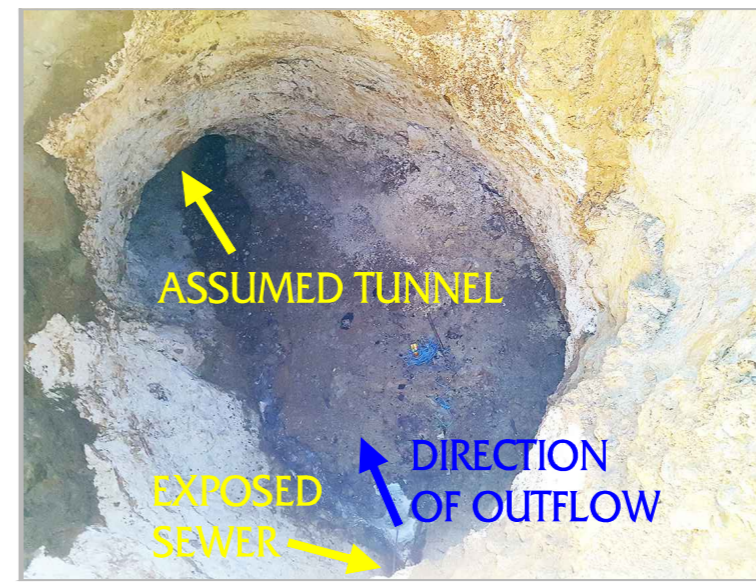
P2b: VIEW INSIDE 'VOID' LOOKING SOUTH EAST

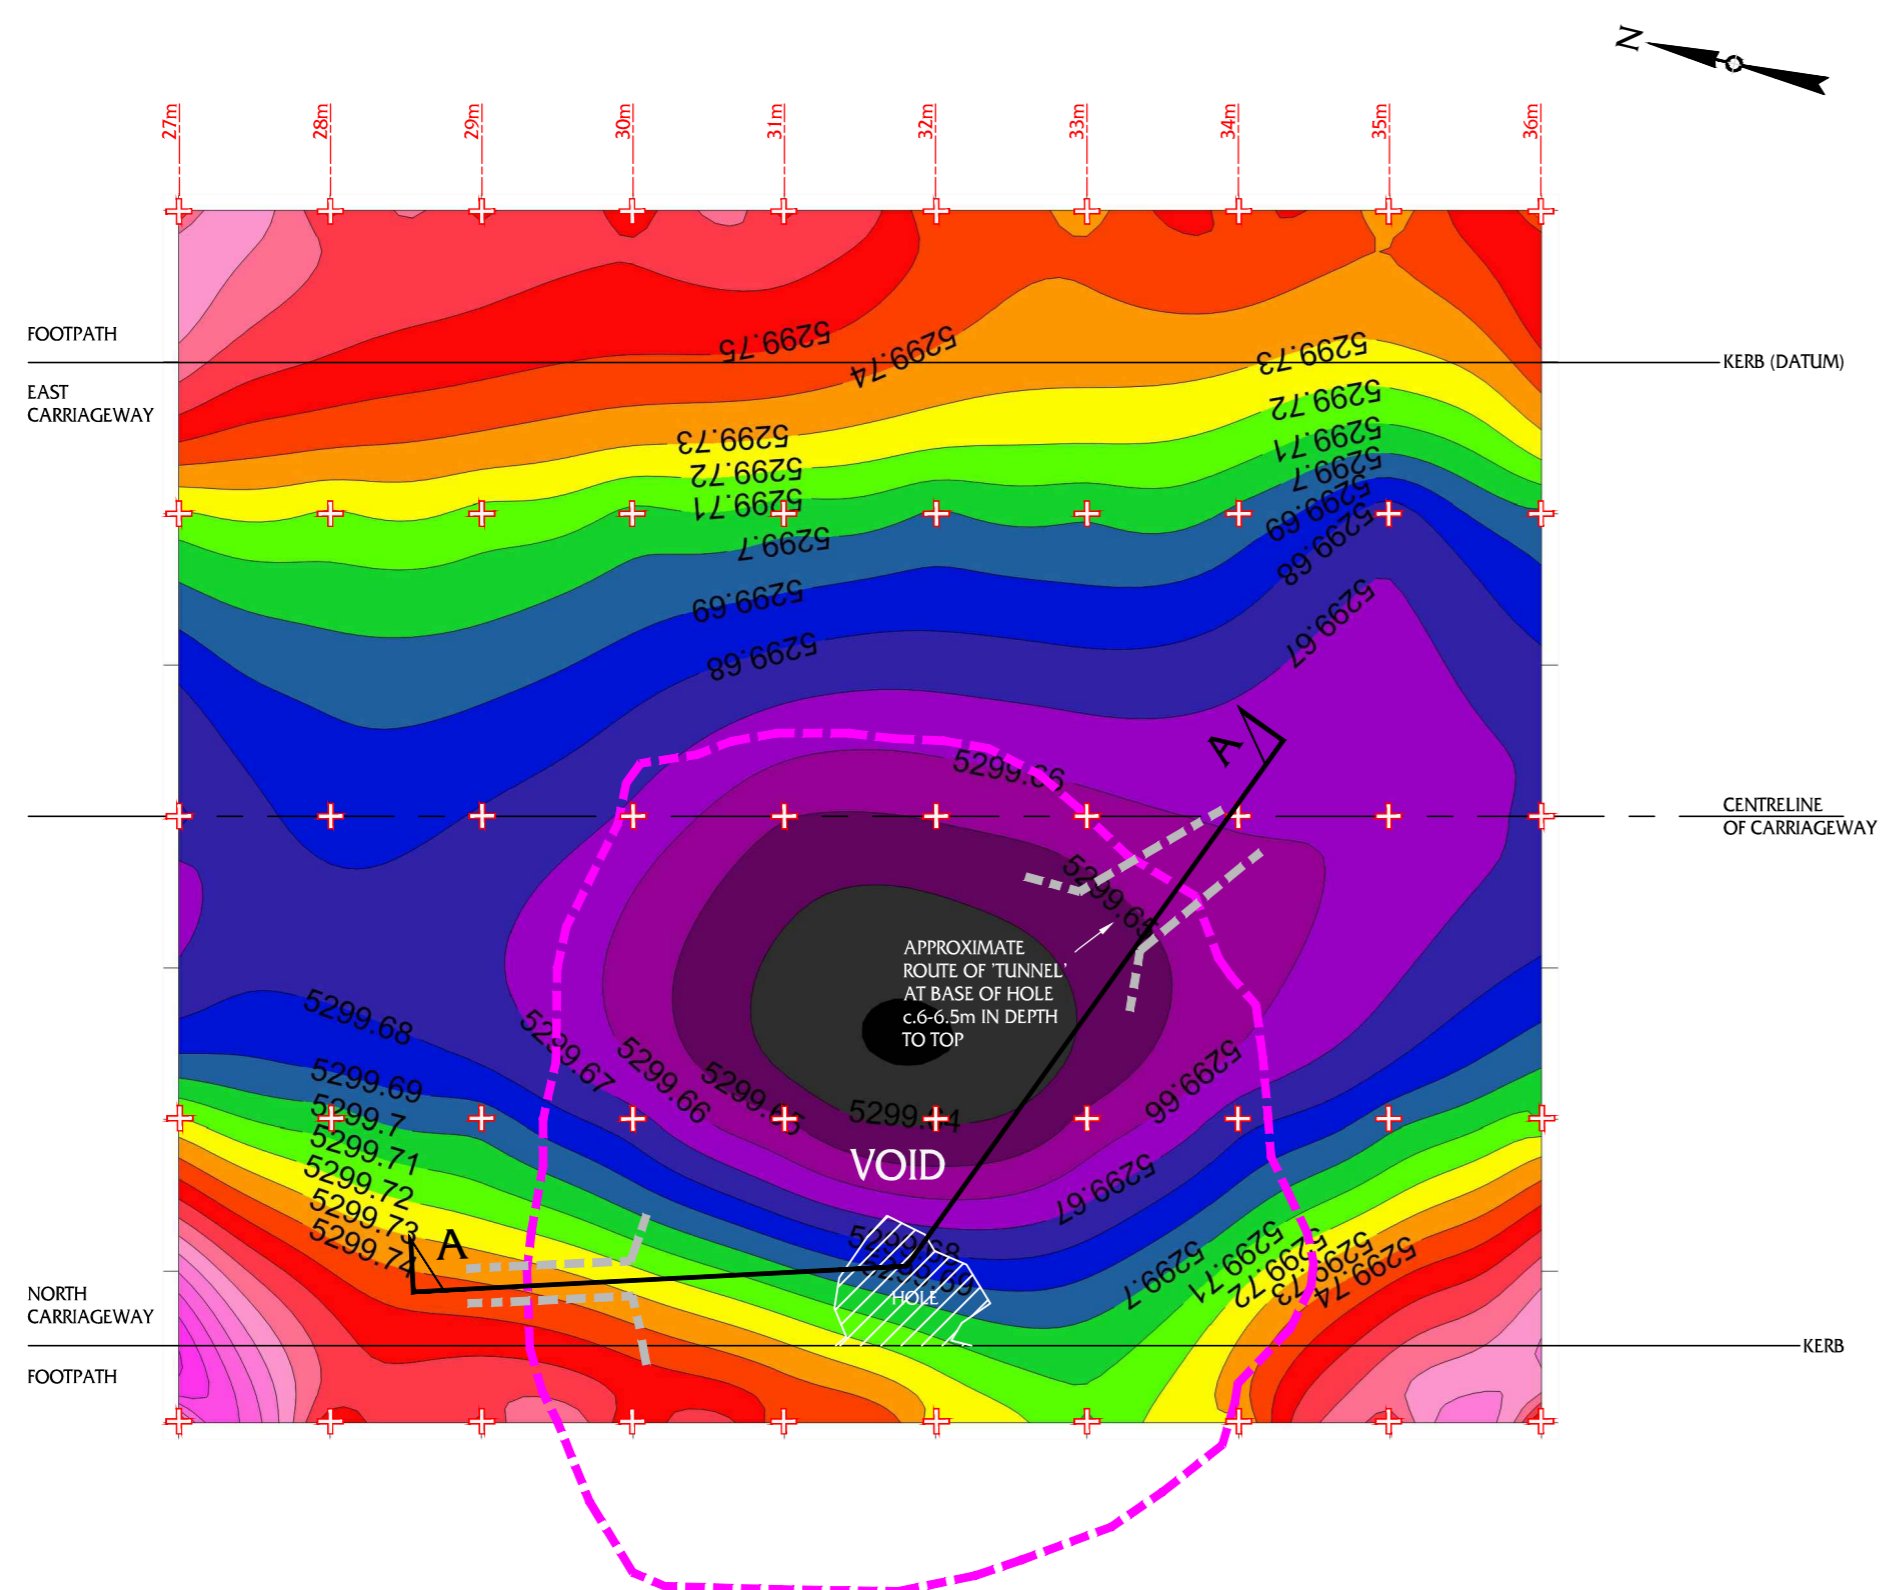
FIG.3: PLAN OF DETAILED SURVEY AREA - MICROGRAVITY RESULTS SCALE 1:50

The results of the microgravity survey are presented as a contour plot at Fig.3 on drawing 4281-2 with the approximate extent of the void identified by Impulse Radar superimposed on top. Additional annotated detailed contour plots, showing only the surveyed road area only are also presented below (these exclude the footpath data).

Where a subsurface void is present it would be expected that the gravity value would be lower, due to an apparent decrease in ground density. In the plots presented, lower gravity values are represented by the darker colours of black through dark purple, consistent with
