**High Street Green, Hemel Hempstead
Hertfordshire, HP2 7AQ**

**NDT/Geophysical Investigation
of Collapsed Ground**

Final Report - 4281

Hertfordshire County Council

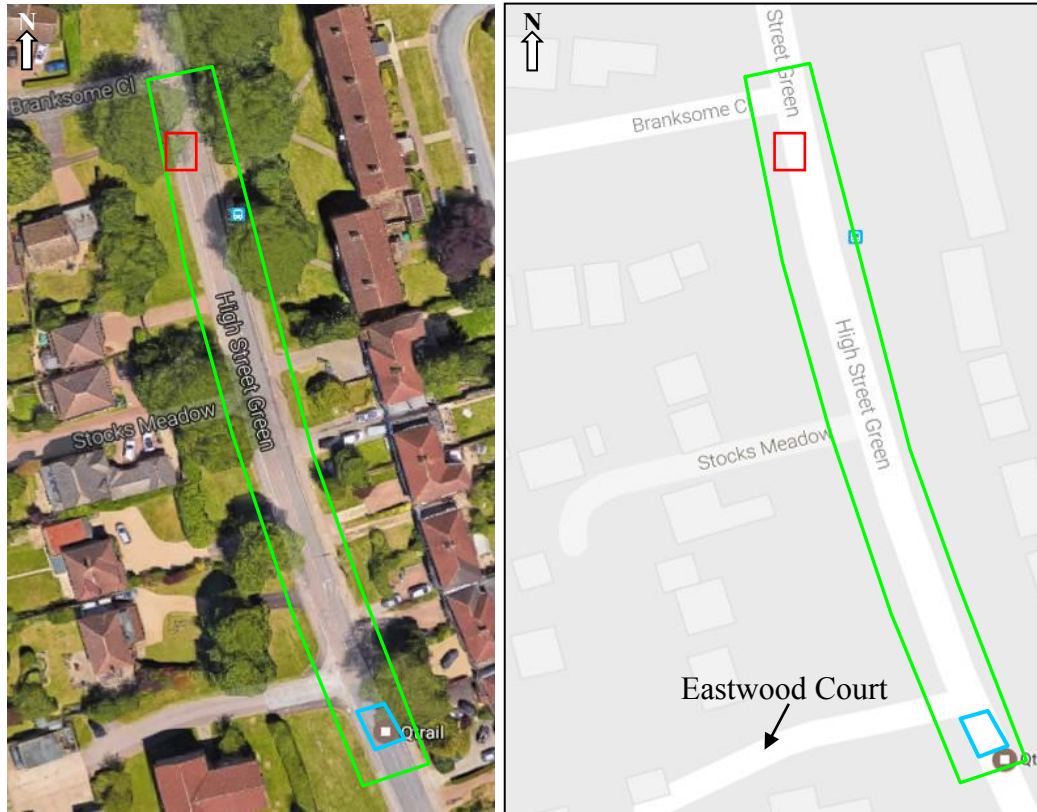
Figure 1 – Survey Area indicated by the green outline. Approximate area around ‘hole’ shown in red and approximate location of visible surface water shown in blue. Not to scale.

In addition to the ‘hole’, further along the road to the south, there is an area where water is visible on the High Street Green Road surface, located immediately to the south of the entrance road into Eastwood Court. It was observed that water was slowly leaking onto the carriageway from below appeared to flow continuously. The water was discoloured with a slight foul smell with frequent suspended sand grains.

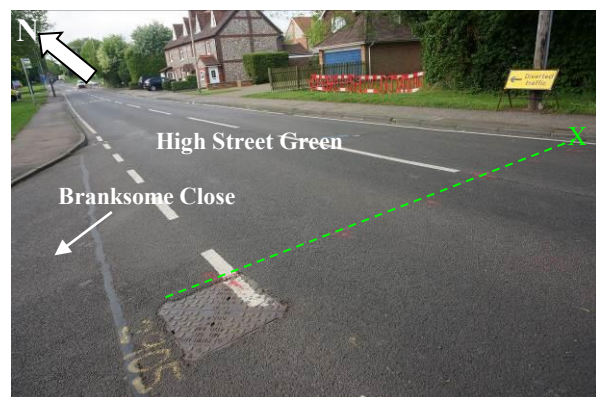
Plate 3 – Approximate position of zero datum shown with a green X (Note Manhole 2905).

The northern edge of a manhole cover (Reference 2905) located at the junction with Branksome Close was selected by the GBG survey team as a zero chainage datum for relocation purposes. A measuring tape was set perpendicular to the edge of the manhole and stretched across the road. Where the tape intersects with the kerb on the eastern side of the carriageway of High Street Green denotes the zero datum.

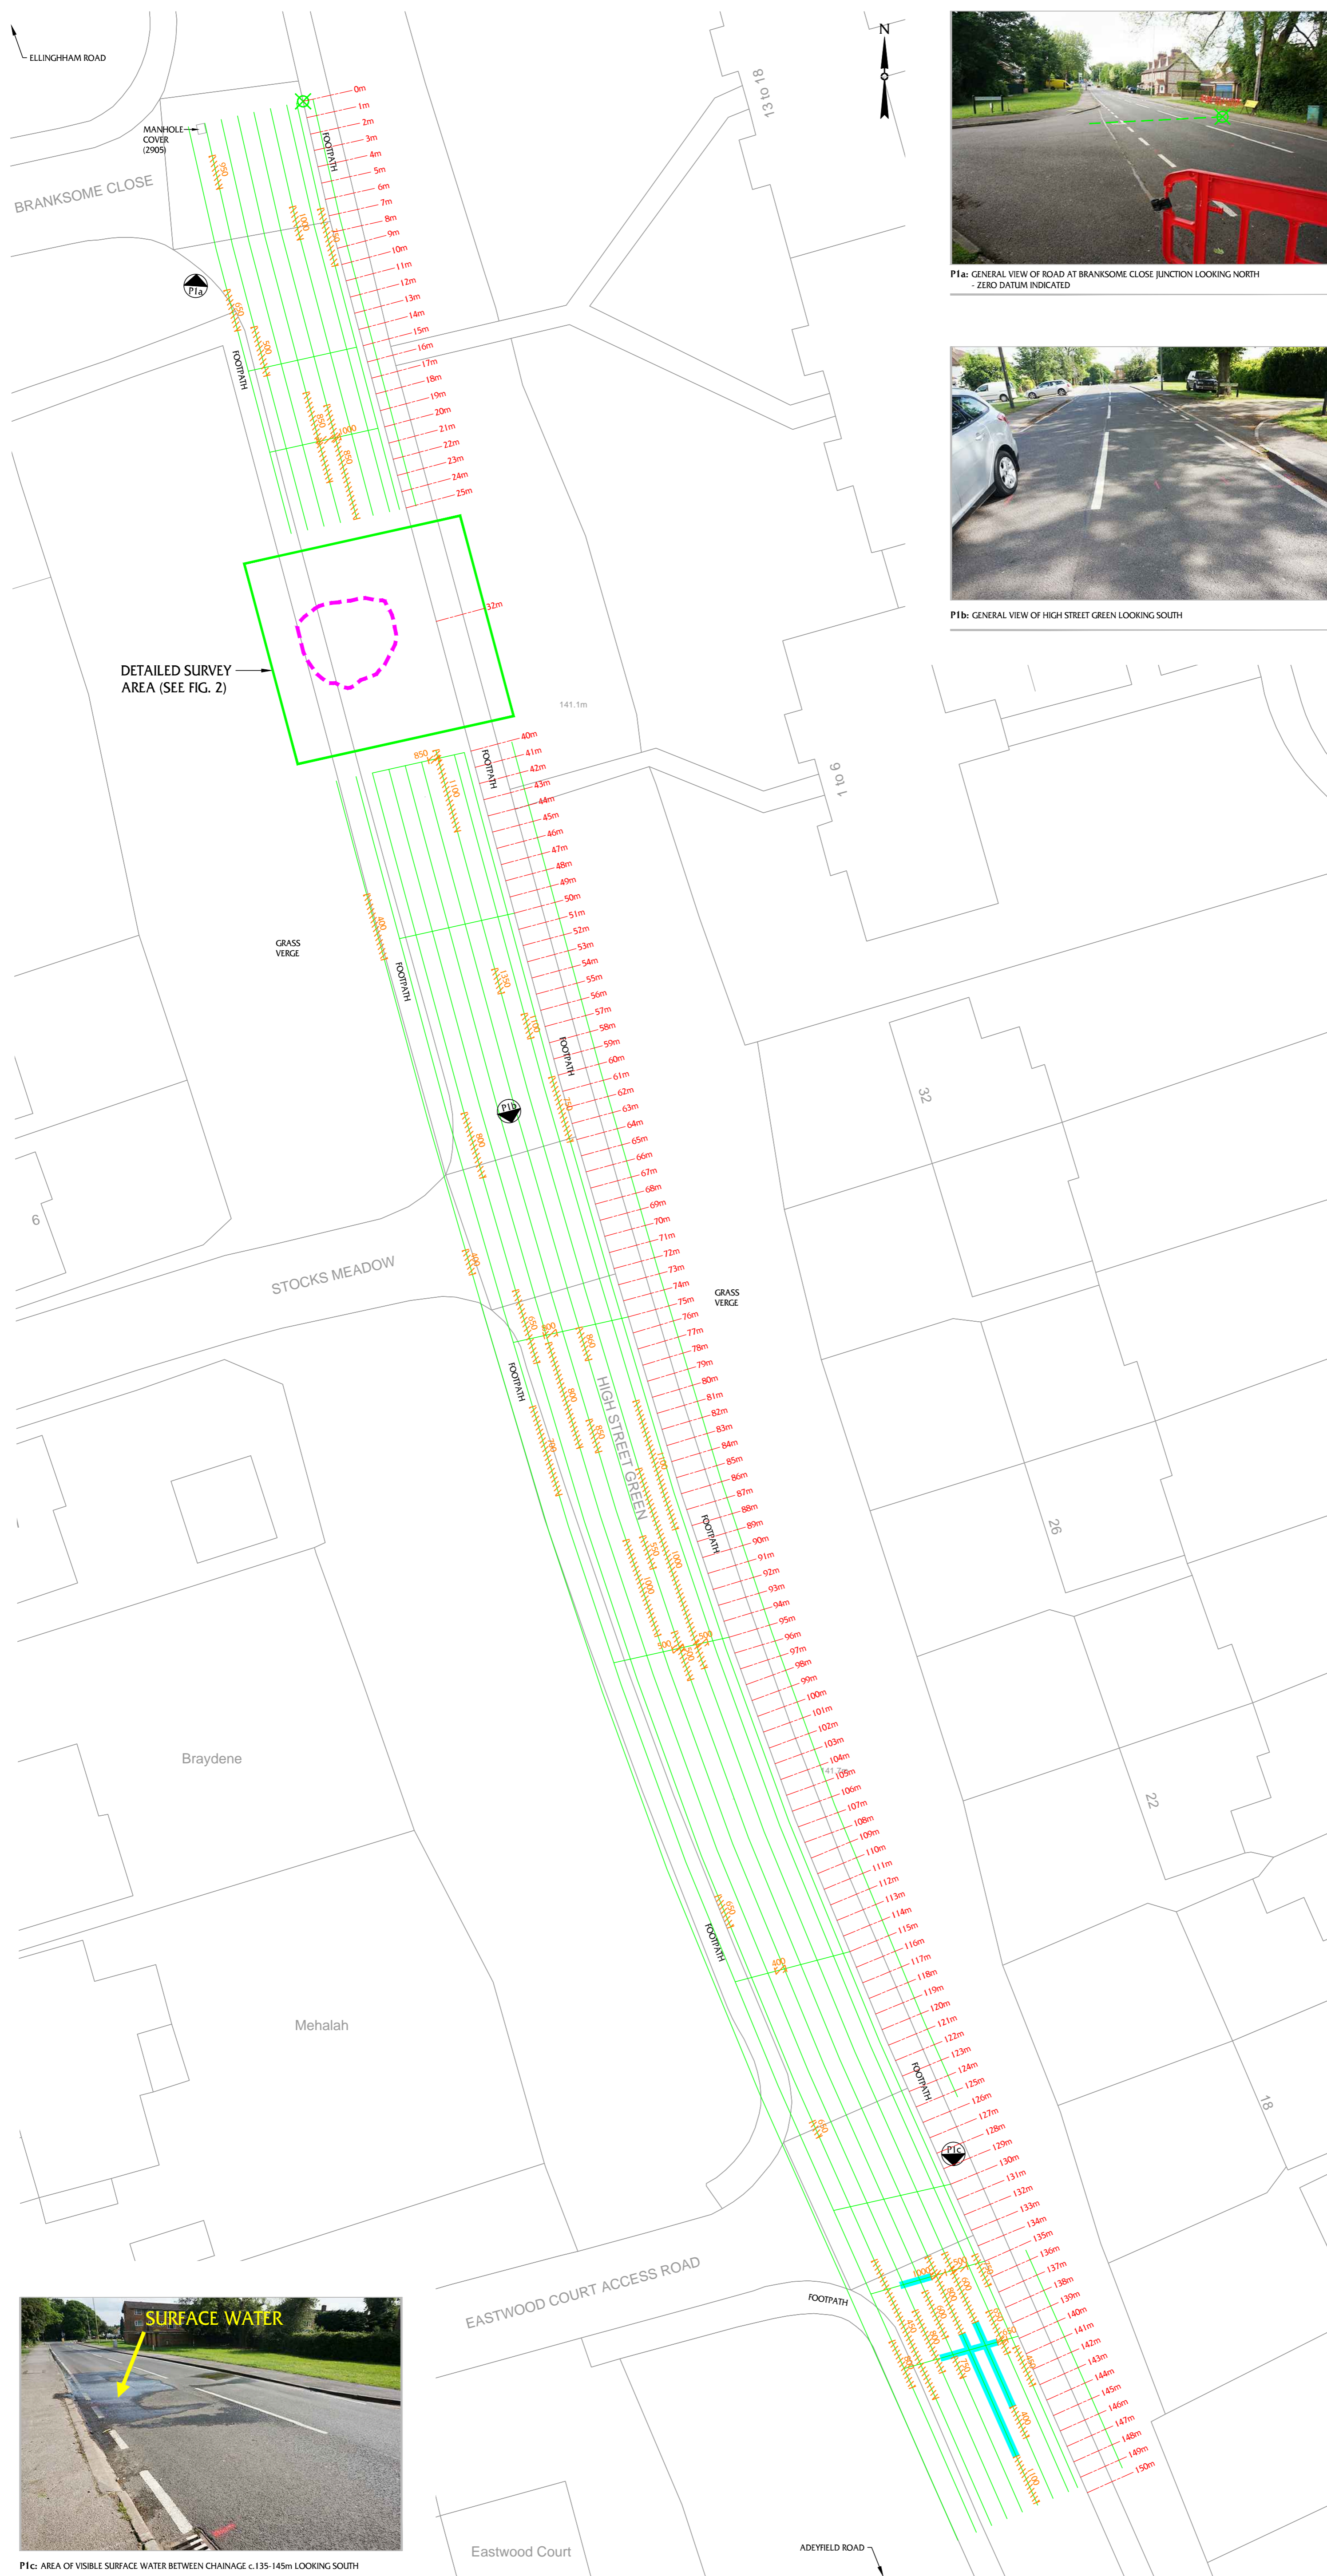
FIG. 1: PLAN OF ENTIRE AREA SURVEYED POSSIBLE SHOWING SUBSURFACE GROUND DISTURBANCE - RECONNAISSANCE SURVEY SCALE 1:200

Areas of ground disturbance are denoted by orange hatching on drawing 4281-1 & 2, at Figs.1 & 3 respectively. These areas were identified using Impulse radar in both of the detailed and reconnaissance survey areas.

It is recommended, where safe to do so, that in some of these locations the ground conditions are proven carefully through intrusive means (either by dynamic probing or boreholes) to establish the full nature of the disturbed ground. Care should be taken around any buried services with no intrusive investigations conducted in the detailed survey area i.e. no intrusive works should be conducted over or around the void.

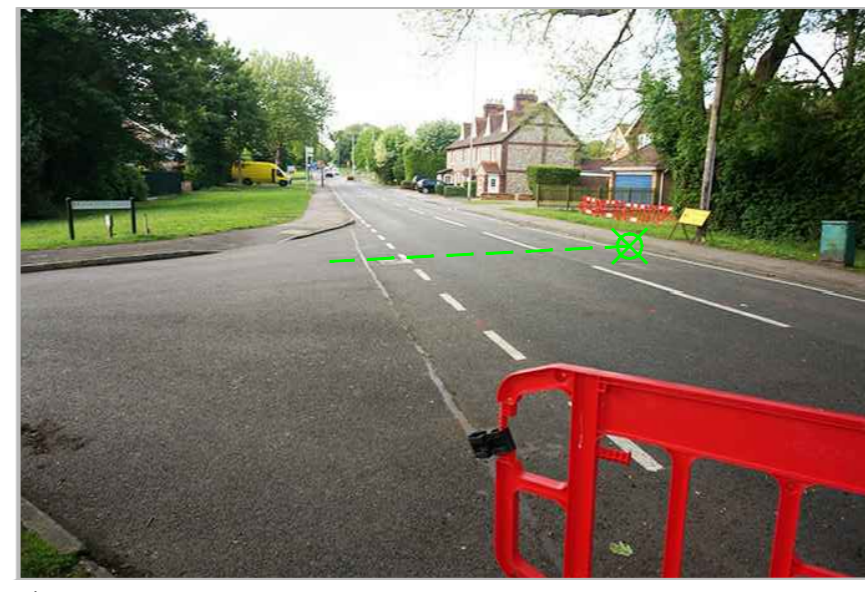
P1a: GENERAL VIEW OF ROAD AT BRANKSOME CLOSE JUNCTION LOOKING NORTH - ZERO DATUM INDICATED

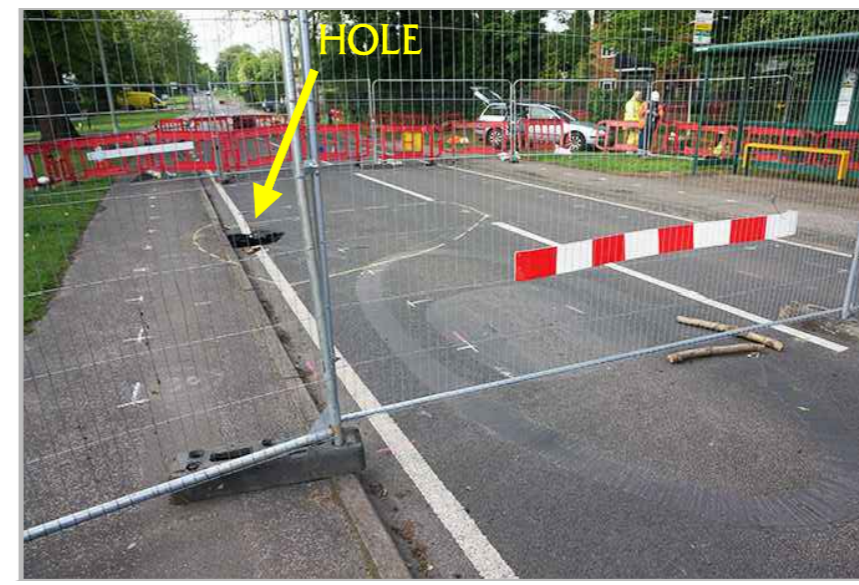
P2a: VIEW OF DETAIL SURVEY AREA LOOKING NORTH - 'HOLE' LOCATION SHOWN

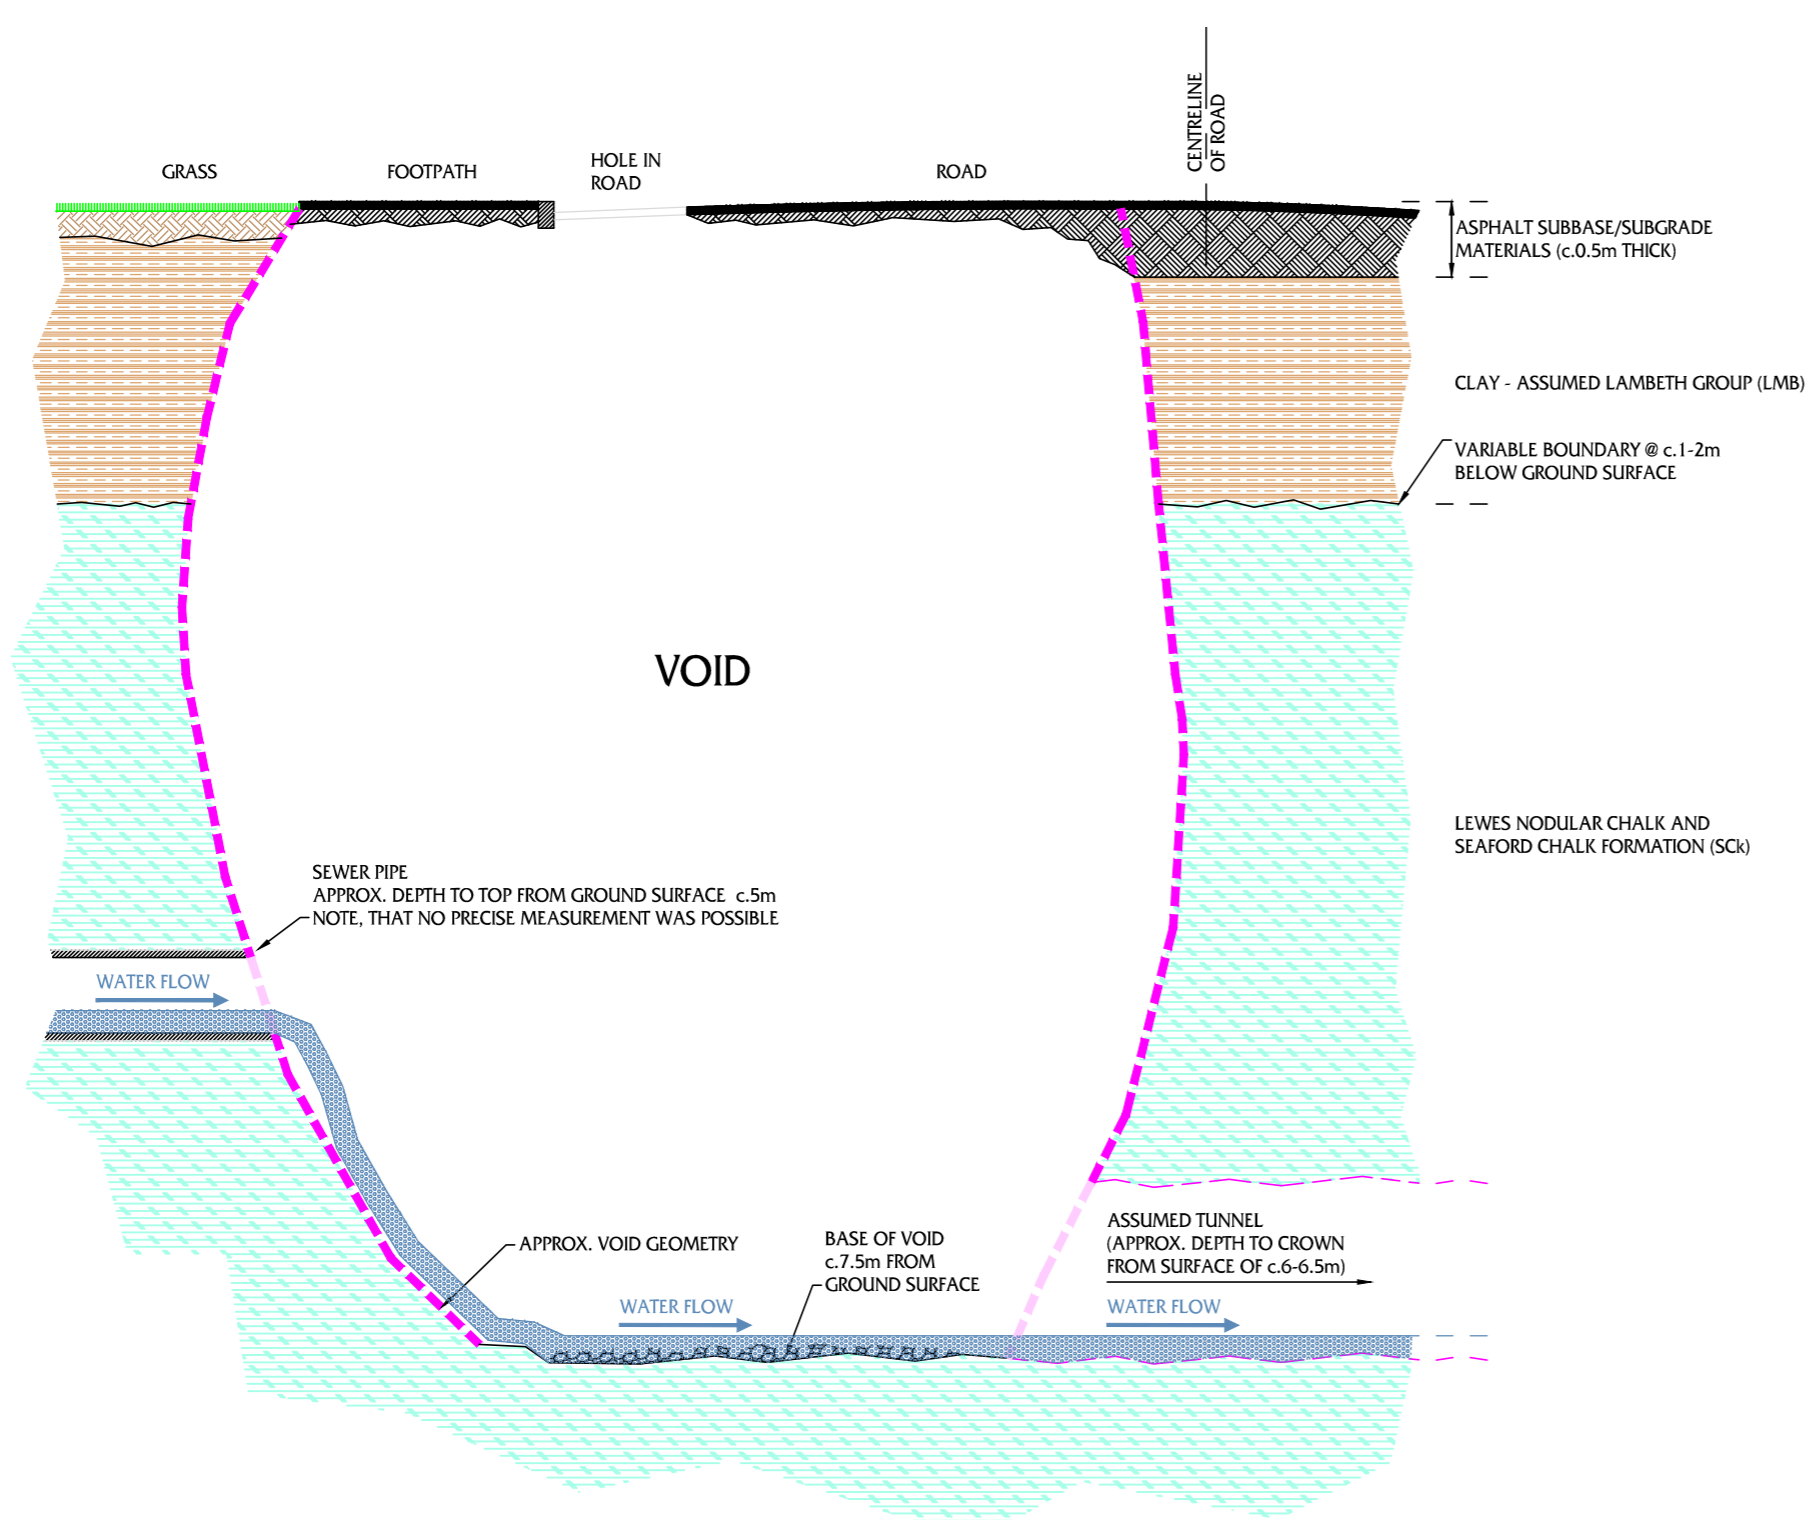
FIG.4: INTERPRETED SCHEMATIC SECTION A-A THROUGH 'VOID' SCALE 1:50

Within the void there is nothing visually to indicate that the leaking service would remain straight, therefore if the 'tunnel' is a continuation of the leaking service there would be a kink in its route, from north-south near the west footpath, to a more south easterly direction which possibly crosses the carriageway. From what can be seen from the 'hole' above there does not appear to be any of the service left within the 'tunnel' Additionally, the depth of the leaking service is shallower than the 'tunnel' indicating a significant change in level, which would be unlikely when constructing a pipe. However, the depths are approximated and it is possible that inaccuracies should mean a less significant change in height consistent with continuation of the service into the 'tunnel'.

- The continuation of the leaking service is unknown, if this does continue into the adjoining 'tunnel' there would be a kink in the route and also a change in level (although depth inaccuracies could account for this).

- A suspected subsurface tunnel was observed extending to a distance of at least c.5.5m to the southeast of the void.
- It is recommended that the 'tunnel' is investigated further to confirm its eastern extent and to confirm that it is not part of a more expansive 'tunnel' network.
